Chassis ID: 8 991632 VIN: YV2XBZ0G5R8991632 Work Order: V-68

TECU-P107538: Inactive  
Occurrences: 30

TECU – Transmission ECU  
P1075 – Clutch System  
38 – Signal Frequency Incorrect

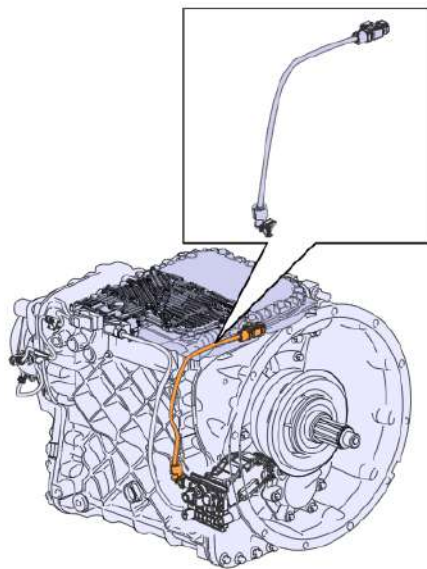
### 1 Air hose, Clutch valve unit

- Check where the leak is with soapy water
- Check for dirt in the air hose by blowing through it with a pneumatic gun
- Check the air hose connections

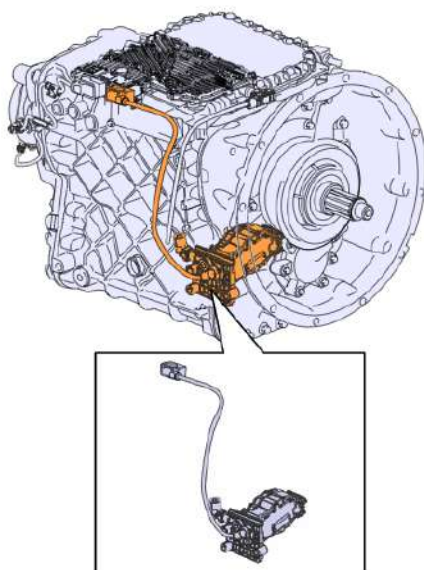
### 2 Clutch Valve unit

1. Visually check that component is not damaged
2. Check that the component is correctly installed
3. Oxidation or corrosion may not be visible unless connections are removed and inspected

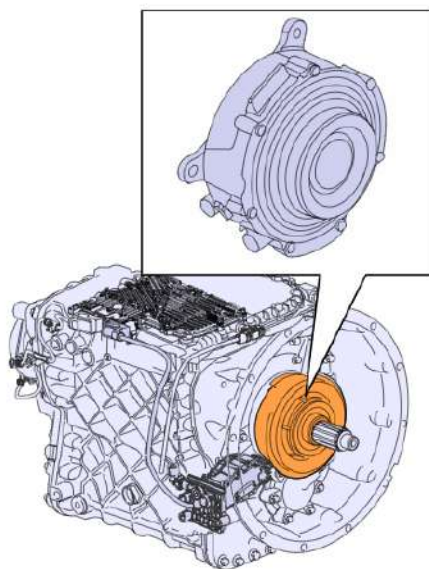
### 3 Clutch cylinder

- Visually check that component is not damaged
- Check that the clutch cylinder mating surface is not worn or damaged
- Spray soapy water on suspect areas to identify leaks

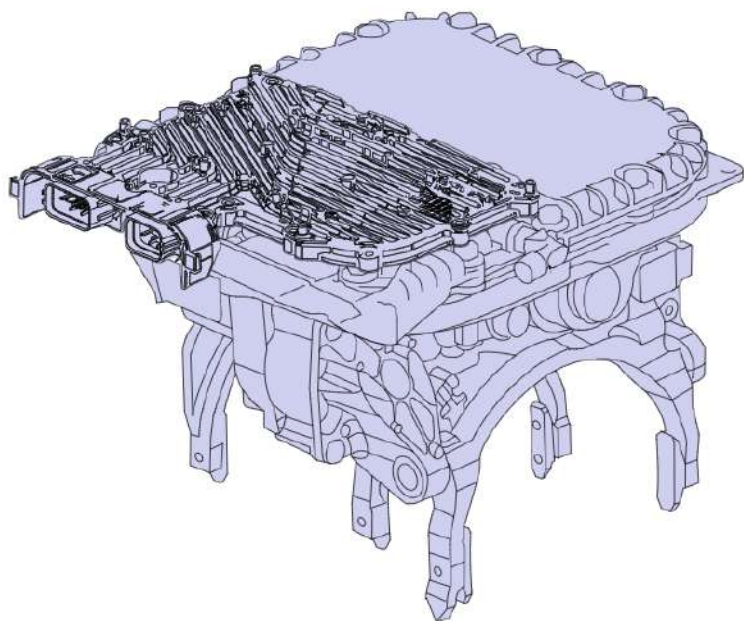
### 4 Control housing, gearbox

Make sure that the air pressure is at least 650 kPa (94.3 psi) in the vehicle

The control housing must be in the vehicle when performing the check

- Listen for air leakage from the control housing
- Check that the connections do not leak
- Check if the upper cover is leaking air
